TURBO-MACHINERY TIP TIMING COMES OF AGE

KAM CHANA, QINETIQ FELLOW AND HEAD OF INSTRUMENTATION AND EXPERIMENTAL PROGRAMMES AND **DONALD LYON** MANAGING DIRECTOR, MONITRAN TECHNOLOGY. (THIS PAPER IS BASED LARGELY ON ONE PRESENTED AT THE ASME TURBO EXPO IN BERLIN, LAST JUNE).

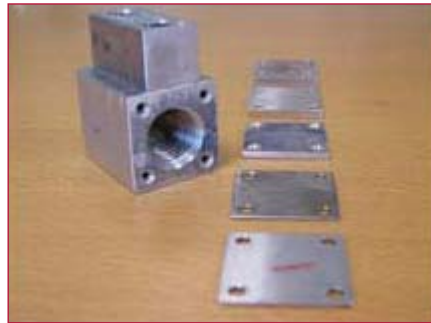
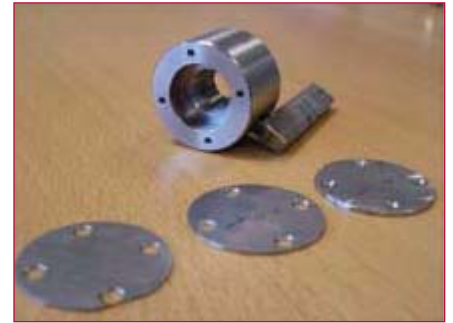
Figures 1(a) and 1(b)
The original (left) and improved (right) pockets and shields

It was found that the pocket design and material had an effect on the sensor performance, and that through-casing measurements did not produce good quality signals when a shield was fitted. To overcome these problems, the pocket was re-designed with an air cavity around the sensor head. Also, the sensor coil was optimised for improved resolution, signal to noise ratio and range.

Tests were then carried out with various tip gaps, ranging from 0.5 to 2.0mm. Although the signal was small in amplitude, it was of reasonable quality, with very well defined peaks when the blades passed by. Figures 1(a) and 1(b) show the original (left) and improved (right) pockets and shields, and Figure 2 compares the measurements from both.

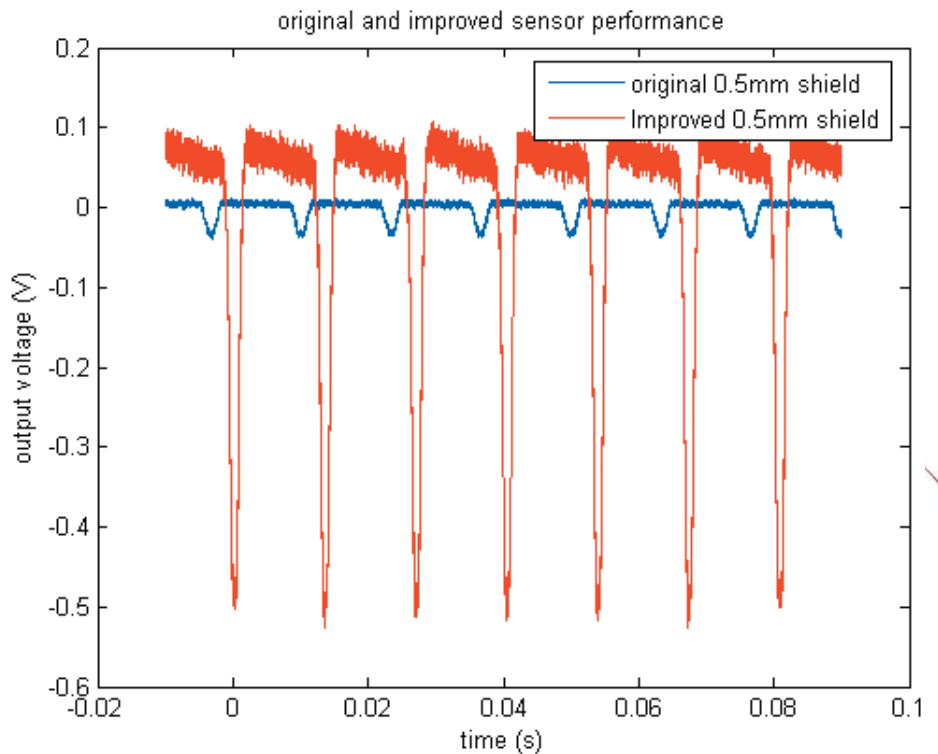
Figure 2 Measurements taken using the original and improved pockets and shields (shown in Figures 1(a) and 1(b) respectively)

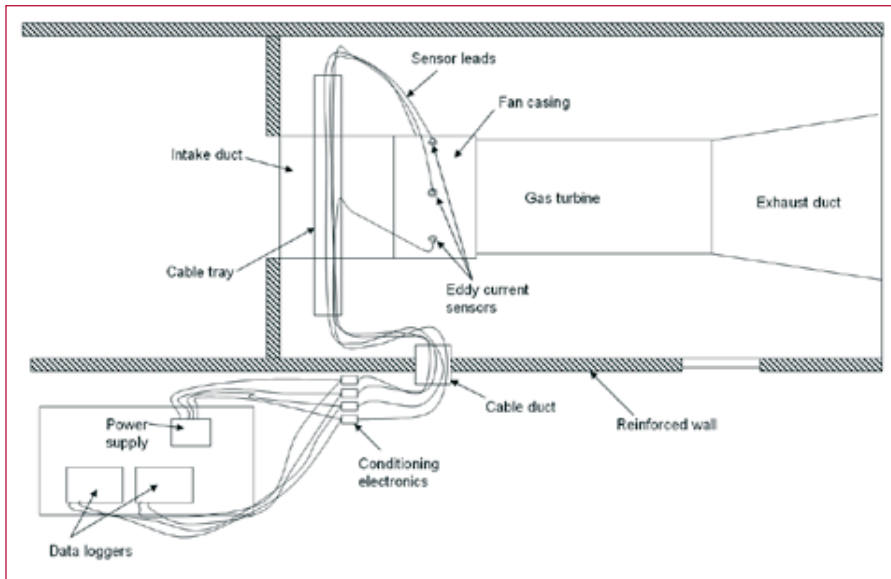
Figure 3 A diagram of the arrangement for the fan tests

A number of tests were carried out, with the engine running at 8700rpm, on the first stage fan rotor of the engine. **Figure 3** shows a schematic of the test cell and the instrumentation configuration.

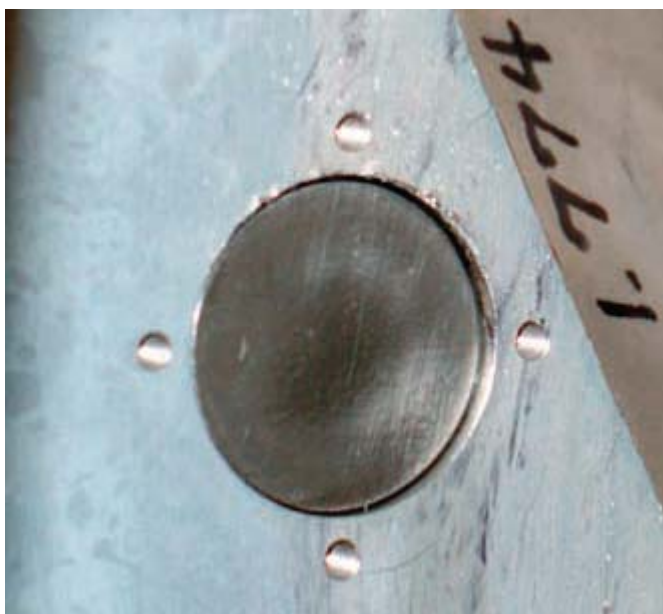
Figure 4 The sensor pocket fitted in the fan casing

Four sensors, in pockets, were mounted into the fan casing. **Figure 4** shows one of these mounting holes from the underside with the sensor pocket fitted. The outside of the casing was spot-faced to allow the pocket to sit squarely on the

casing and the sensor was positioned with its centreline at approximately 0.3 axial chord. While this reduced the signal strength, placing the sensor head nearer the leading or trailing edge resulted in a better measurement of the blade vibrations.

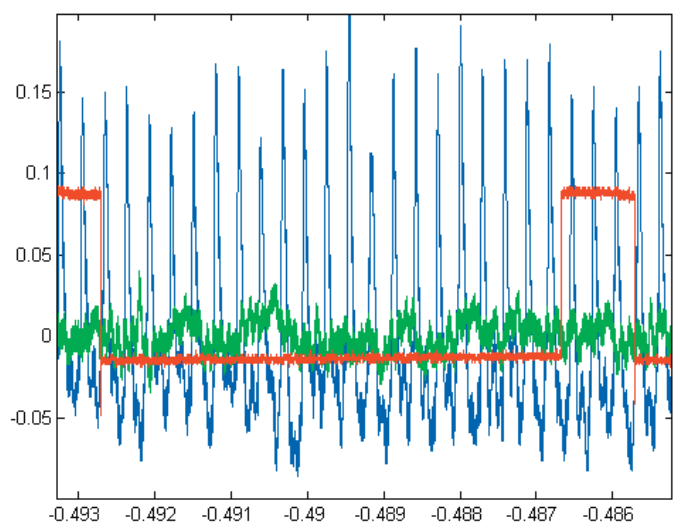
Figure 5 The initial sensor's output through casings of thickness 0.75mm (blue) and 1.0mm (green)

comparison of the different results. **Figure 5** shows an example of the sensor outputs with the engine at full speed. The red trace is a once per rev. signal measuring the engine low pressure shaft speed using a speed encoder.

Through the (blue) 0.75mm shield the sensor is clearly able to pick up the blade passing, with 24 clearly defined peaks per revolution. The peaks are not all the same height, indicating the variation in blade tip clearance from the casing. For the 1.0mm shield the sensor captured some blade data, but it was not of sufficient quality for tip timing purposes.

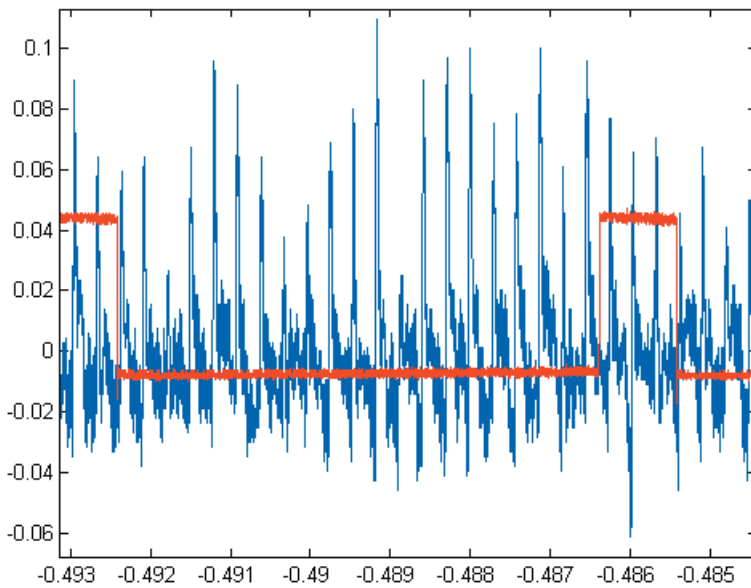
Figure 6 The sensor's output through a 1.0mm thickness casing following reduction of the tip clearance

Having addressed the 'static clearance' issue a number of tests were then conducted to compare shield thicknesses under more realistic operating conditions. **Figure 6** shows the sensor output through the 1.0mm shield, and it can be seen that there are significant differences in peak values [blue trace]. Similar results were obtained using 1.25 and 1.5mm shields, except that all peaks were slightly lower. It was still possible to count all the blade passings, despite the extra thickness of shield.

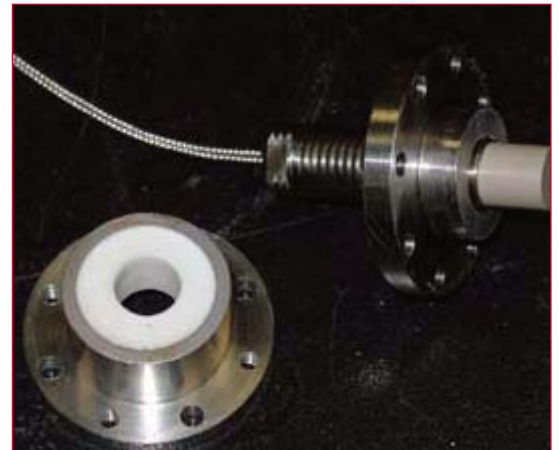
Figure 7 The sensor pocket machined to allow direct line of sight from the sensor to the blade tip

After the acquisition, through a shield, of blade passing data, the ends of the pockets were machined off to allow such data to be taken without any intervening material between the sensor head and the blade tips. **Figure 7** shows one of the modified pockets prior to being fitted back on to the engine, and **Figure 8** shows data from one sensor taken at full speed.

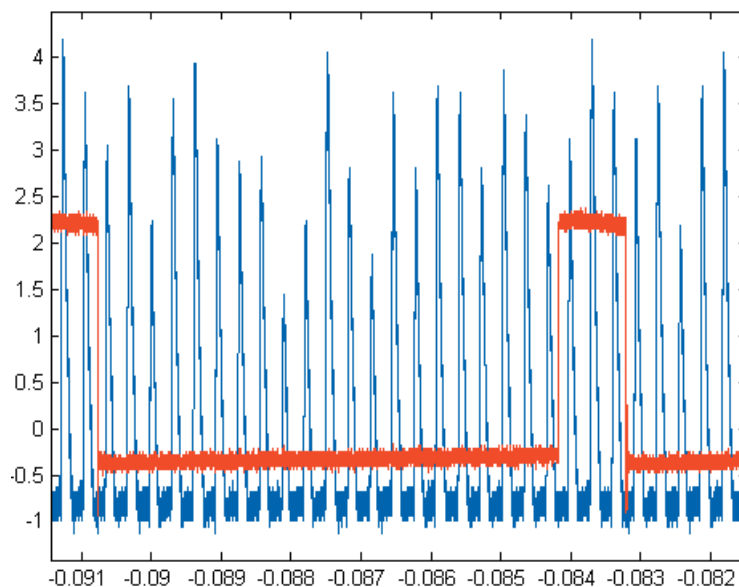
Figure 8 The output from the casing sensor during engine operation at full speed

Not surprisingly, the output is much larger with no shield present and the blade passing is clearly visible. In addition, the base noise level is much reduced in comparison to the 'through case' data. In order to be of use in a blade tip timing system, data from sensors must be adequately monitored

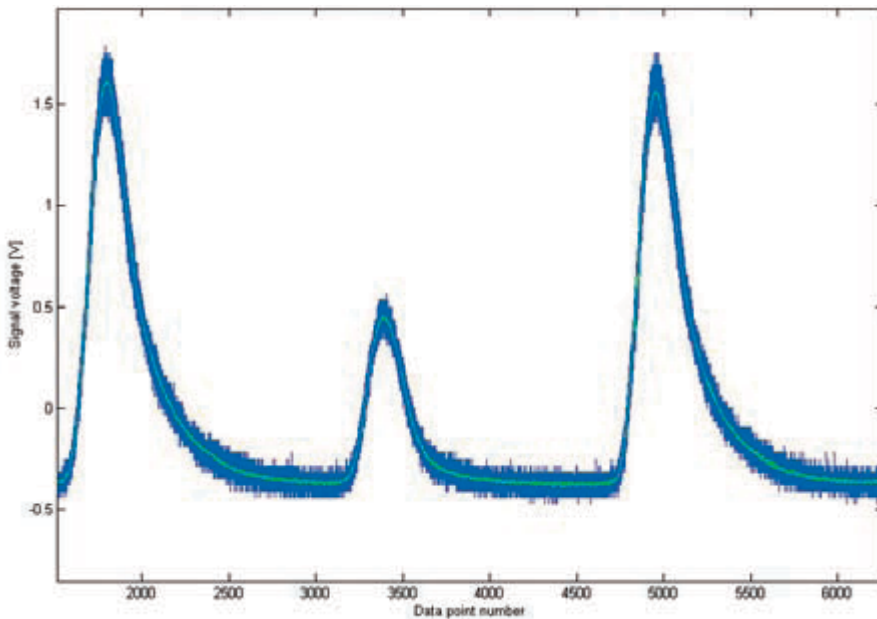
Figure 9 Sensor output data rev-to-rev and averaged (the white, inner trace)

The eddy current sensors used in the tests proved sensitive to the tip clearance. However, the pulse shape generated by each blade was not significantly altered, suggesting that a repeatable amplitude-independent triggering technique would be possible. **Figure 9** is a plot of data rev-on-rev from a single data file containing 26 revolutions. Three blade passings are plotted, with the ensemble averaged data over-plotted. The plot demonstrates that the sensor output is repeatable where the tip clearance is maintained at a near constant value.

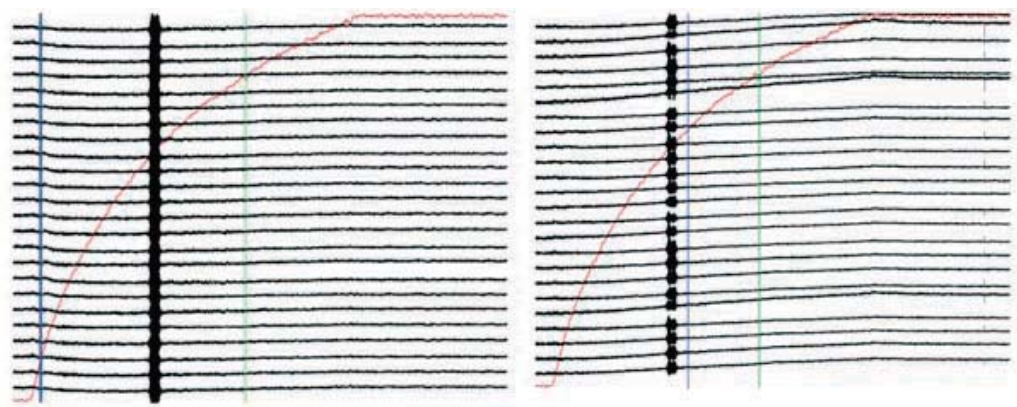
Figure 10 Individual blade waterfall plots – data obtained using a leading optical probe (left) compared against data obtained by the eddy current sensor (right)

increases the signal amplitude increases, causing a shift in the triggering position which shows up as a change in arrival time. This results in the output for some blades shifting in relation to the adjacent blades. In both plots, a large blade vibration is detected during the engine acceleration at around 6200 RPM.

and the signals generally have a very sharp rising edge, with the result that threshold triggering systems work well with these probes. This can be seen in **Figure 10**, which shows data from optical and eddy current probes which were input to a standard technology system for the acquisition and analysis of tip timing probe data⁵. For the optical probe data on the left, the arrival time essentially remains flat, except for the fluctuations caused by blade flutter. On the right, the eddy current sensor data shows that as the engine speed

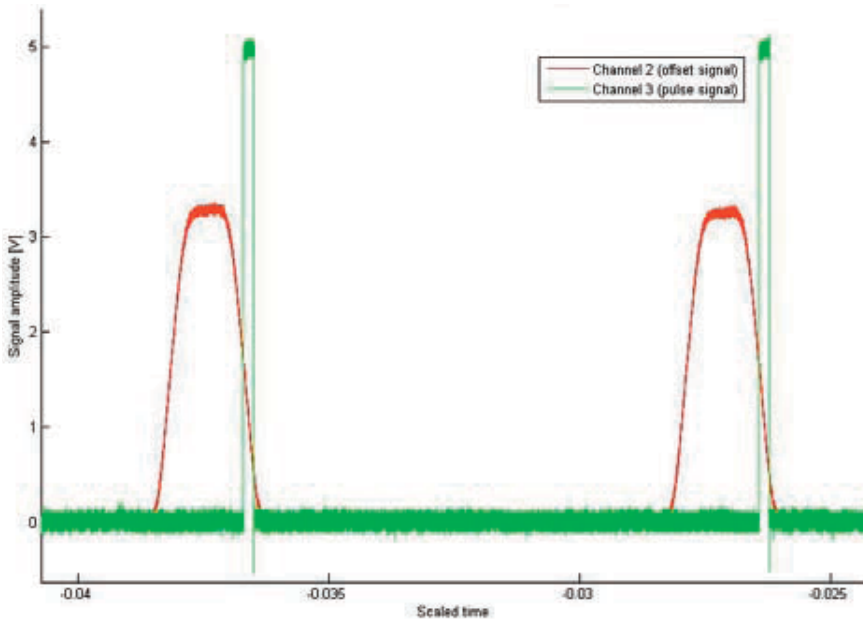
Figure 11 Falling-edge triggering technique, producing an output with a relatively square wave

Blade arrival times calculated from an amplitude-corrected signal showed promise and it was decided to embed the correction into the signal-conditioning hardware, so it could be performed in real time. The signal conditioning system produced a square wave output, which was fed into an acquisition system that used a threshold triggering system. **Figure 11** shows the raw and output signals from the signal conditioning system, with the output pulse occurring on the falling edge of the raw signal. The conditioning was performed using analogue electronics. >>

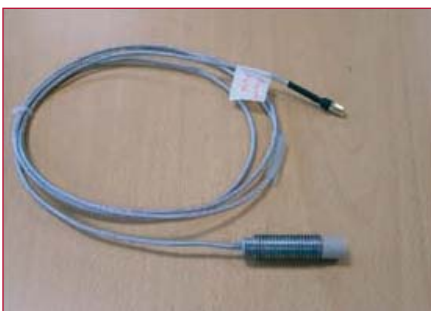
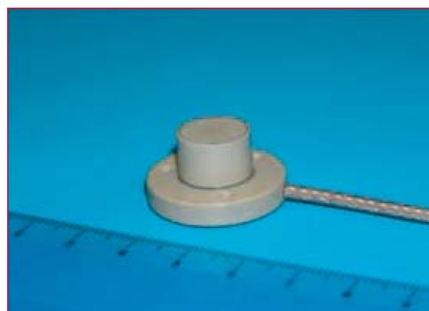
Figure 12 Examples of the eddy current sensors developed by QinetiQ and Monitran Technology

Figure 12 shows two of the eddy current sensors developed by QinetiQ and Monitran for turbo machinery blade tip-timing. ■
